DEPARTMENT OF TRANSPORTATION
RAYMOND T. SCHULER, Commissioner

BRIDGE DECK WATERPROOFING MEMBRANES -
HIGHWAY MAINTENANCE PROJECTS

First Interim Report
January, 1976

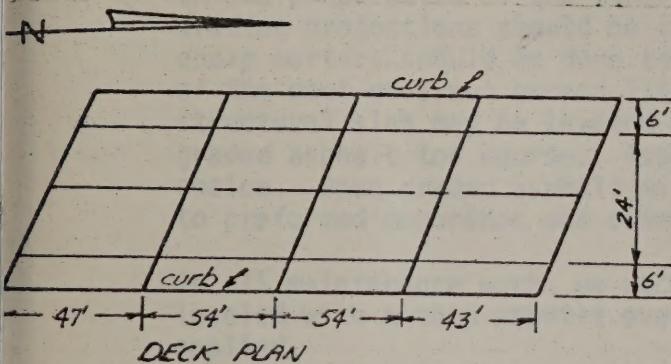
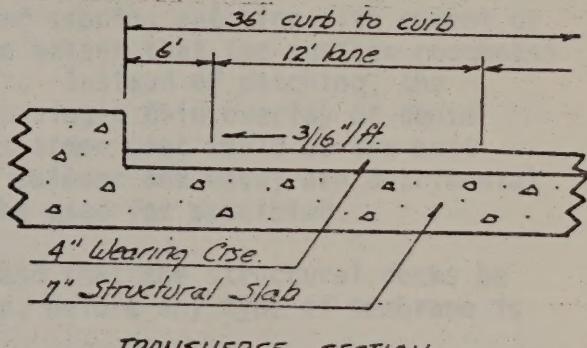
Bridge #1043450 - Rte. 253 (Washington St.) over I-490, Monroe County

The Heavy Duty Bituthene membrane was installed in September, 1974. The membrane was placed on a concrete structural deck and overlayed with a 4" asphalt wearing course. The structural deck was in good condition, although two damp areas were visible from the underside. Before the membrane was placed the surface of the deck was leveled by patching with cement mortar. This leveling improved the surface of the structural deck, but unevenness and roughness remained.

Resistance readings were taken one month (10/74) after membrane placement. These measurements showed an average resistance, over the entire deck of 2150 kil-ohms (24 points). A second evaluation of the structure was made in June, 1975, nine months after membrane placement. A visual examination showed no evidence of deterioration. The damp areas appearing on the underside of the deck when the membrane was placed had dried up. The average resistance for the 24 measurements was 1750 kil-ohms. However, this figure is misleading since the majority of the higher resistance readings (> 500 kil-ohms) were recorded at the curb sections and areas outside of the travel lanes. In the travel lanes, measurements of less than 100 kil-ohms were common. We believe that these low resistances are due to punctures in the membrane, caused by sharp protrusions and surface roughness in the structural deck.

Heavy Duty Bituthene is recommended for futher use.

In maintenance operations, additional effort will have to be placed on the preparation of the concrete structural deck. Sharp and protruding projections should be ground smooth; patching with cement or epoxy mortars should be done to the extent that the surface roughness of the deck does not exceed 1/4"/ft. Instead of patching, the structural slab may be leveled by paving a thin overlay of dense graded asphalt top course. Asphalt armor coat would be the best choice. Open graded asphalt mixes (binder and base) are detrimental to preformed membranes and cannot be used for smoothing.

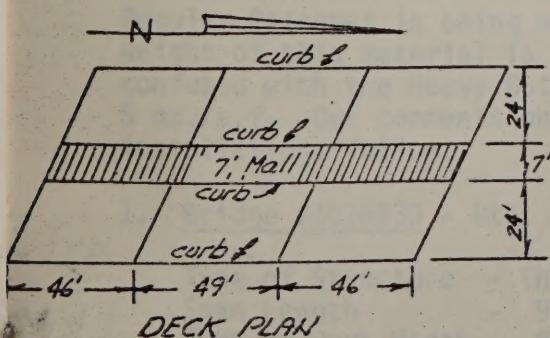
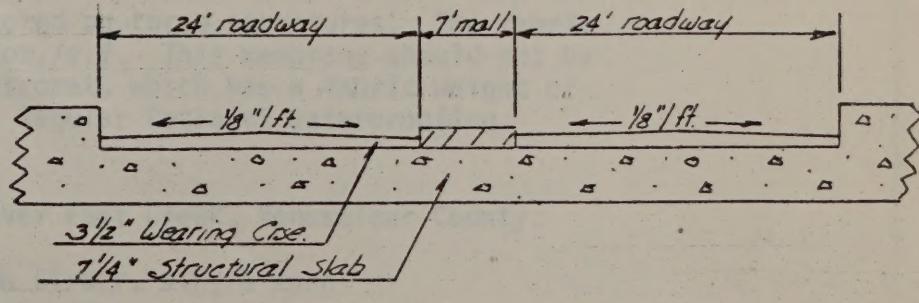
Bridge #1007220 - Rte. 9W over Rte. 307, Orange Co.

The fiberglass and asphalt membrane was placed in September, 1974. The waterproofing was placed on the concrete structural deck and overlayed with 3½"-4" of asphalt. The structural deck was generally in good condition. Some deterioration was noted in a few localized areas; the underside of the deck showed some evidence of leakage and efflorescence. The surface of the deck was rough and uneven, but no attempt was made to level and correct this situation.

Initial resistance measurements were recorded in November, 1974. These measurements were taken in wet weather and consequently gave low readings. They are erroneous and will not be reported. A second evaluation was made in October, 1975, 13 months after placement. Visually, the structure was in good condition. The wet areas and efflorescence that had been noted before had dried up - except that under the center dividing mall where the membrane had not been placed, some dampness could be seen. The average resistance for the deck (N.B. & S.B. lanes - 36 points) was measured at 3650 kil-ohms. On this structure the wheelpath areas were located and it is of interest to note that the average resistance in the wheelpaths was 2950 kil-ohms (21 points) as compared to an average of 4550 kil-ohms in areas outside the wheelpath (15 points). This would tend to indicate a weakening of the membrane system in the area of the wheelpaths.

No recommendation is made, pending further investigation of the Fiberglass and Asphalt system.

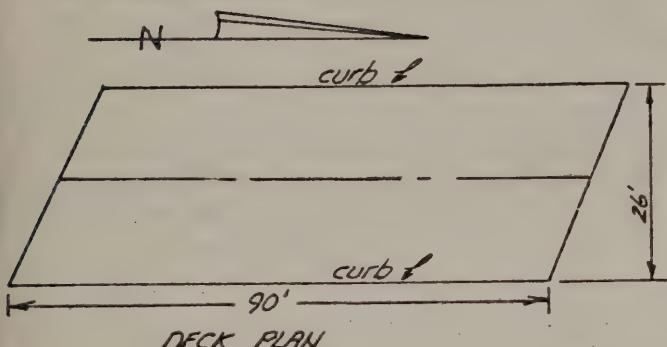
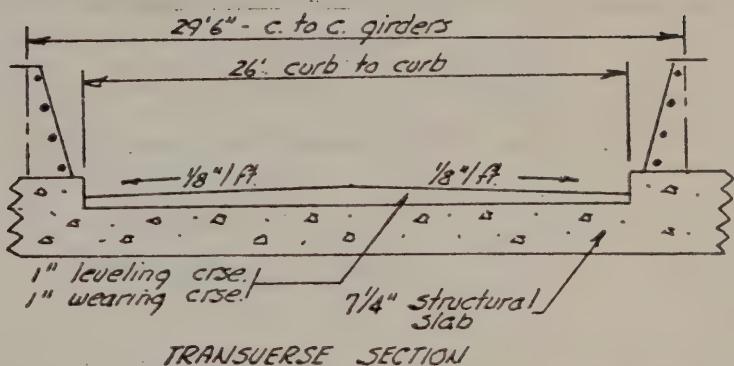
1. Bridge #1016930 - Rte. 22 over East Creek, Rensselaer County.

Regular Petromat waterproofing membrane was installed in July, 1974. The membrane was placed on 1" of asphalt armor coat that was laid to level the structural deck and then overlayed with a 1" asphalt wearing course. Visual observations at the time of membrane placement showed that the structural deck was in good condition.

The first resistance measurements were taken in November, 1974, 5 months after membrane placement. The average resistance for 12 points was 535 kil-ohms. Again the wheelpath areas were located. The average resistance in the wheelpaths (5 points) was 210 kil-ohms; areas outside of the wheelpath showed an average of 765 kil-ohms (7 points).

This deck was re-surveyed in November, 1975. Visually, no deterioration or leakage was noted, except that spalling at the concrete curb section left a few small areas of the membrane exposed. It was decided to increase the number of resistance measurements to 24 points in this survey. The average resistance for all points on the deck was recorded as 180 kil-ohms. The average resistance in the wheelpaths was 90 kil-ohms (12 points); in areas outside of the wheelpaths; 270 kil-ohms (12 points).

Regular Petromat (fabric weight = 4.2 oz./s.f.) is not recommended at the present time, pending further investigation of existing systems.

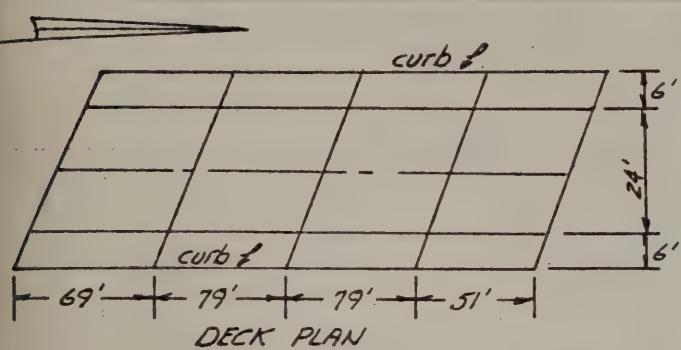
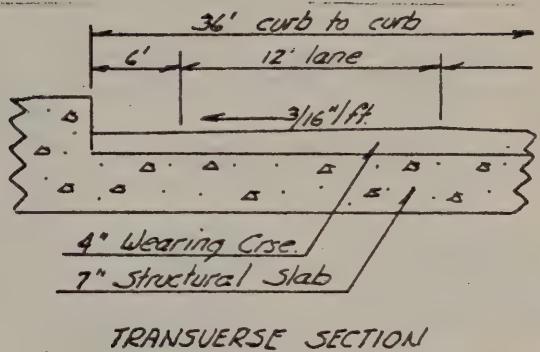
2. Bridge #1013830 - Route 209 over Rte. 17, Sullivan County

Regular Petromat was placed in September, 1974. The structural deck was in good condition although visible leakage was noted at the expansion joints. Badly scaled areas were leveled with asphalt armor coat, but this was not applied to smoother concrete surfaces. After placement, the membrane system was overlayed with 4" of asphalt.

Resistance measurements were taken on 25 points in November, 1974, 2 months after membrane installation. The average resistance for all points was 36 kil-ohms. Breaking this down, the average of wheelpath measurements was 25 kil-ohms (10 points); outside the wheelpaths was 43 kil-ohms (15 points). Rain the previous day may have had some influence on these low values.

A second evaluation was made in October, 1975 after 13 months of service. Visual observations showed no deterioration. The average resistance on the deck was recorded at 1650 kil-ohms (25 points). This figure is high due to inclusion of "maximum" measurements (>50,000 kil-ohms) that were recorded in the 6' breakdown lanes. Without these measurements, the average falls to 62 kil-ohms. The average resistance in the wheelpaths was 21 kil-ohms (10 points); in the lane, outside the wheelpaths - 100 kil-ohms without the maximum readings and 2740 kil-ohms with the curb-lane measurements included.

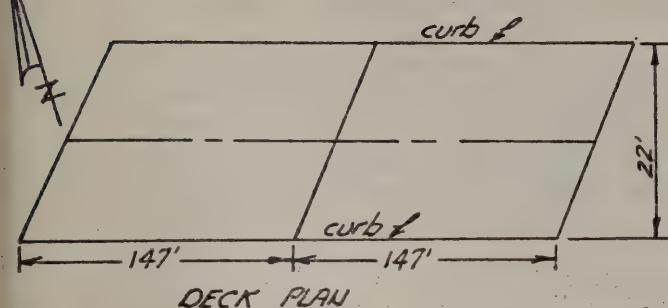
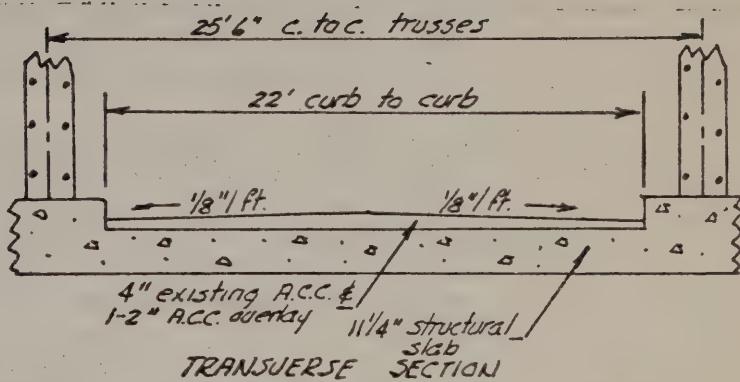
3. Bridge #1024020 - Rte. 37C over Racquette R., St. Lawrence County

The Regular Petromat was placed in the southbound lanes in July, 1975. The waterproofing was laid directly on the existing asphalt wearing course, which was in excellent condition, and then overlayed with 1-2" of asphalt. The underside of the deck was in poorer condition, numerous longitudinal cracks were present and most showed evidence of leakage and efflorescence.

The first evaluation of the bridge was made in October, 3 months after placement. Visually, the deck looked good. The wet spots had dried up. The average resistance for 15 points was recorded as 266 kil-ohms. Wheelpath locations were not recorded in this survey and no further breakdown of measurements can be made.
